PIC16C73

PIC16C73 Rev. A Silicon Errata Sheet

The PIC16C73 (Rev. A) parts you have received conform functionally to the Device Data Sheet (DS30390**E**), except for the anomalies described below.

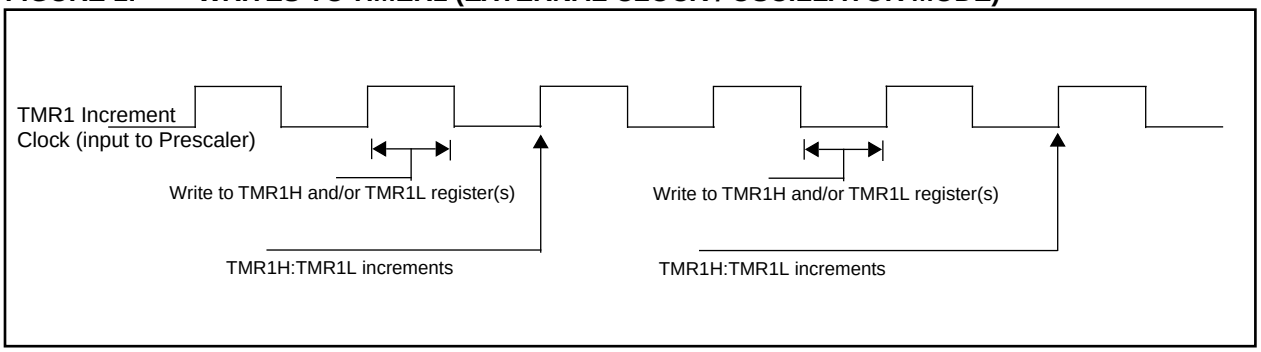
FIGURE 1: WRITES TO TIMER1 (EXTERNAL CLOCK / OSCILLATOR MODE)

a) The operation of Timer1 needs some clarification when the timer registers are written when the TMR1ON bit is set.

The internal clock signal that is the input to the TMR1 presaler affects the incrementing of Timer1 (TMR1H:TMR1L registers and the Timer1 prescaler). When the Timer1 registers are NOT written, the Timer1 will increment on the rising edge of the TMR1 increment clock.

When the TMR1H and/or TMR1L registers are written while this clock is high, TMR1 will increment on the next rising edge of this clock.

When the TMR1H and/or TMR1L registers are written while this clock is low, TMR1 will not increment on the next rising edge of this clock, but must first have a falling clock and the the rising clock for TMR1 to increment.

Figure 1 shows the two cases of writes to the TMR1H and/or TMR1L registers. Due to the V_{IH} and V_{IL} thresholds on the oscillator/clock pins, external Timer1 oscillator components, and external clock frequency, the Timer1 increment clock may not be of a 50% duty cycle.

The TMR1 increment clock is out of phase of the T1OSO/T1CKI pin by a small propagation delay.
